## Fire Damage Assessment of Reinforced Concrete Buildings Under Construction

Khalid Ahmad Almazrouei<sup>1</sup>, Mohamed Ezzat Hussein<sup>2</sup>

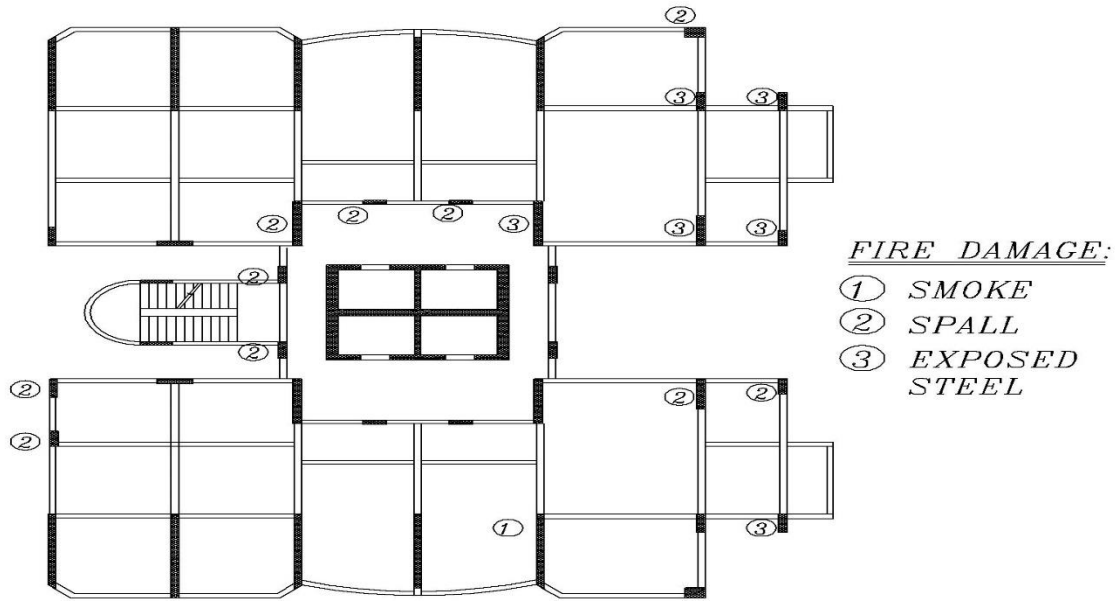
- Spalling to about 80% of the surface of one face.
- Exposed horizontal bars in few cases.
- Smoke damage to the other columns.
- Buckling of the exposed Reinforcing steel.

Figures (5) & (6) shows fire damage to the columns / walls in zone (1) and (2) respectively.

Figure 5: fire damage to 8<sup>th</sup> floor RC. columns/walls zone1

3. Concrete and Reinforcing steel for columns/walls of 8<sup>th</sup> floor was removed since it was recently cast (3 – 10 days old) and suffered from spall damage due to fire effect. In addition, core tests for column shows significant reduction in strength.

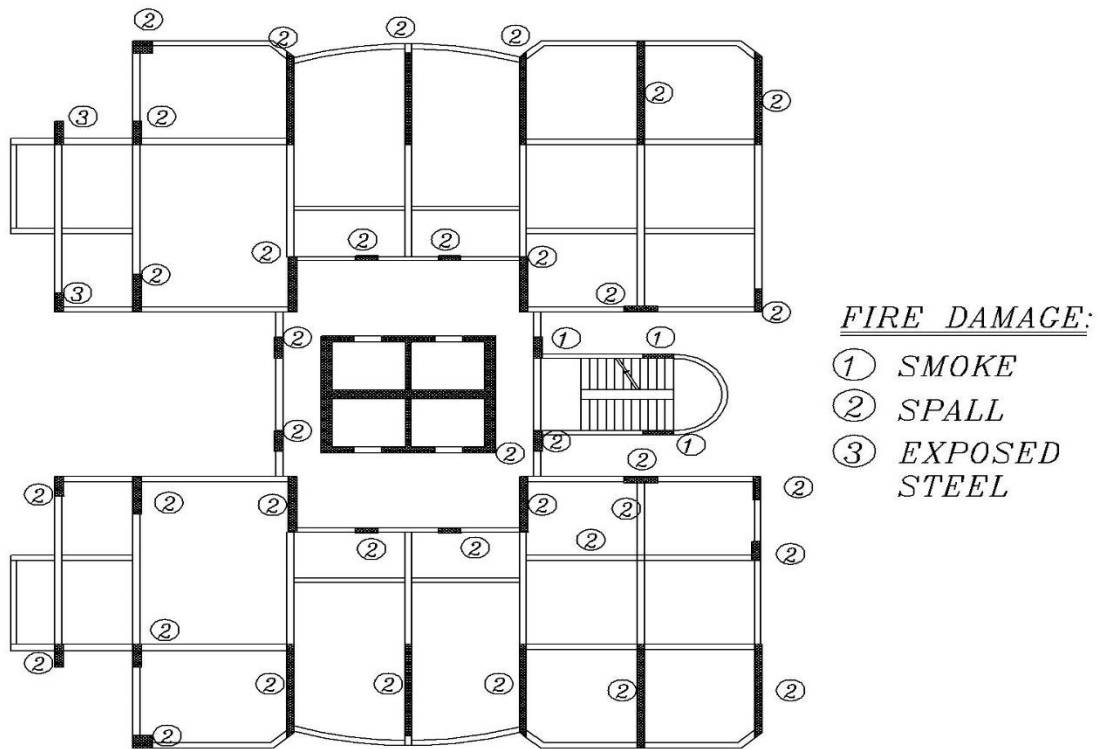
Figure 6: fire damage to 8<sup>th</sup> floor RC. columns/walls zone2

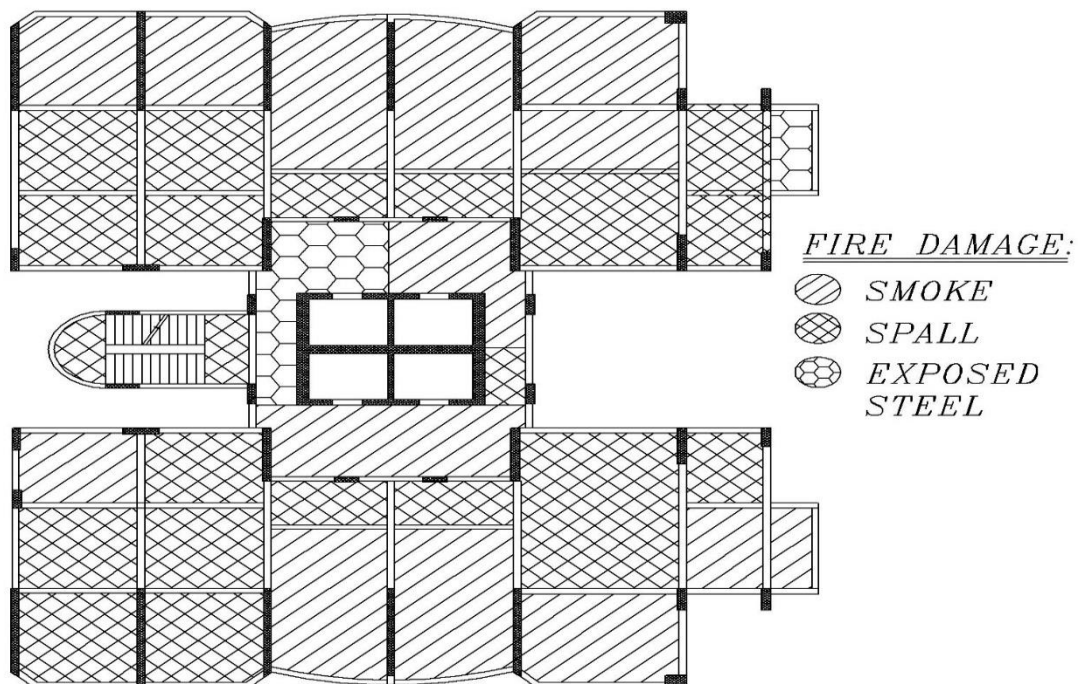
The damage to the slabs of zone (1) varies significantly over the soffit as follows:

- Spalling concrete without exposed rebar under most of slabs.
- Exposed rebar in same slabs.
- Smoke damage to the rest of slabs.

The damage to the beams in zone (1) was less than the slabs while the main longitudinal reinforcement was not visible the damage to beams was observed as follows:

- Spalling concrete to small areas of the soffit and corners.
- Exposed stirrups at the sides and soffit of a few beams.
- Smoke damage to most beams.

Figures (7) shows fire damage to the 7<sup>th</sup> floor slab in zone (1).

Figure 7: fire damage to 7<sup>th</sup> floor slabs zone1

4. Concrete and Reinforcing steel for columns/walls and slabs of 7<sup>th</sup> floor was removed (except Columns, walls, cores located at southeast part of elevators core of 7<sup>th</sup> floor zone 2) since it was recently cast (8 – 19 days old) and suffered from severe damage while core tests for columns shows excessive strength reduction.

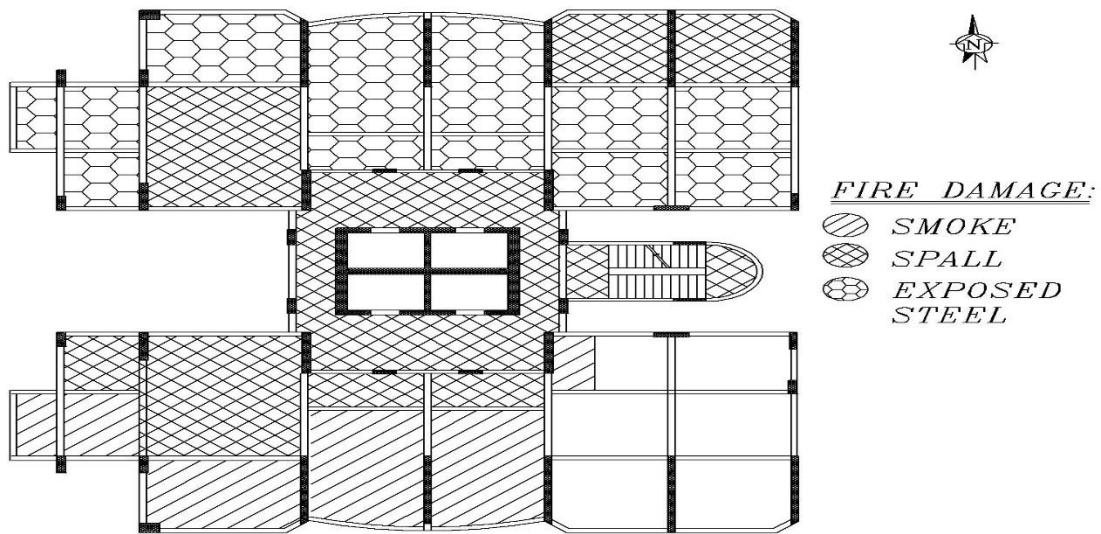
The damage to the slabs in zone (2) is varied significantly between panels as follows:

- Severe damage to the slabs located at the north side of elevators core.
- Exposed rebar (two layers) at the same area.

- Spall and Smoke damage to slabs located at south of elevators core.
  - No fire damage was observed to slabs located at southeast of elevators core.
- The damage to beams in zone (2) was observed as follows:
- Severe damage to most beams located at the north side of elevators' core.
  - Exposed stirrups at the sides and soffits of few beams.
  - Spall and Smoke damage to some beams located at the south side of elevators core except southeast side.
- The damage to the columns and walls in zone (2) was observed as follows:
- Spalling concrete to most of columns.
  - Smoke damage near to top of columns and walls.
- Figure (8) shows fire damage to the 7th floor zone (2)

Figure 8: fire damage to 7<sup>th</sup> floor slabs zone2

5. Columns, walls and cores located at southeast part of elevators core of 7<sup>th</sup> floor zone 2 were repaired as per repair procedure (Class 4) described in this study since it was recently cast (19 days old) and generally suffered from spall damage. in addition, core tests for this members shows significant reduction in compressive strength.
