## DATA COLLECTION TECHNIQUES IN OPEN CHANNEL IRRIGATION SYSTEM (THE EGYPTIAN CASE STUDY)

N. Abdelazim<sup>1</sup>, M. Samy<sup>2</sup>, K. Toubar<sup>3</sup>,

1 PhD Researcher, 2 Professor of Hydraulics (Ain Shams University), 3 Doctor of Engineering MWRI

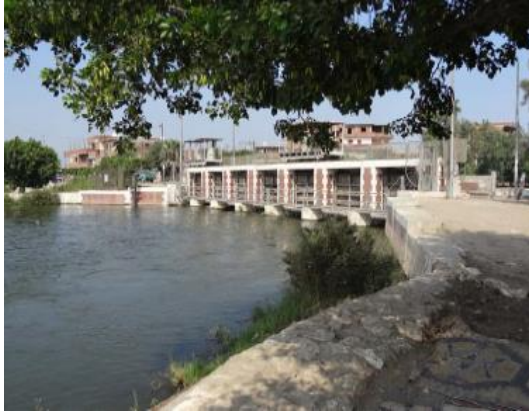
Photo (1): General view of BMHR from the D.S.

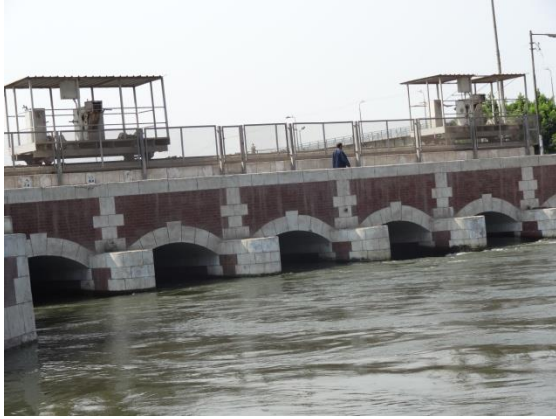
Photo (3): General view of Regulator U.S.

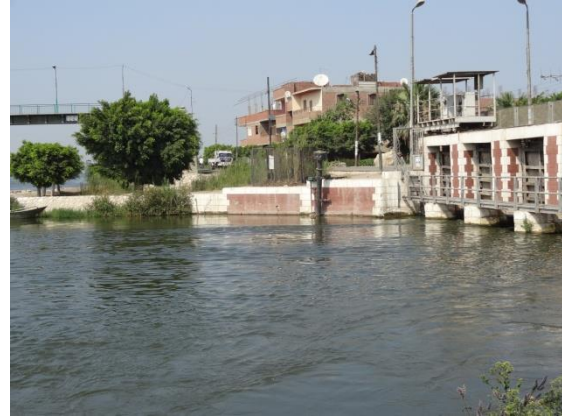
Photo (4): Wing wall, D.S.

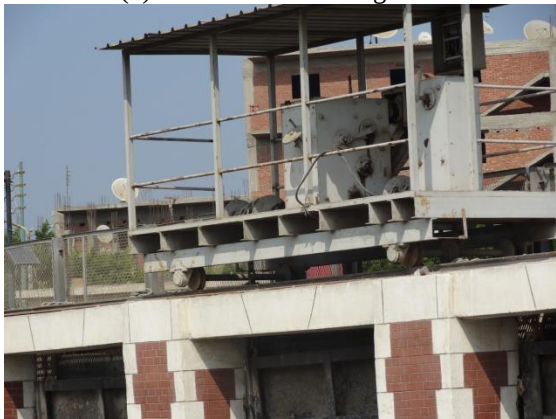
Photo (5): Gate lifting system

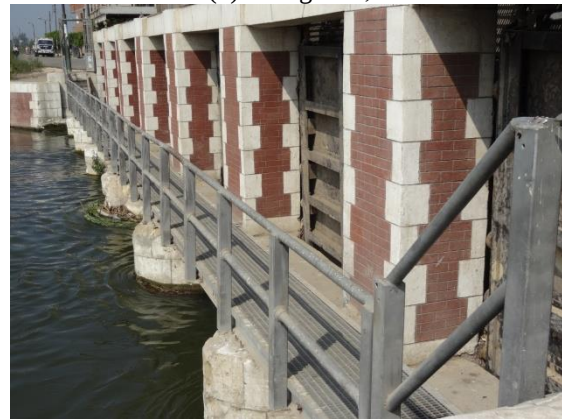
Photo (6): Regulator gates

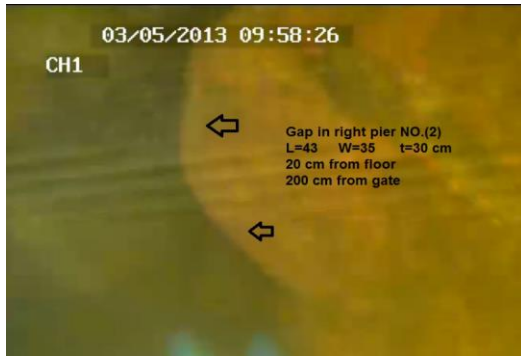
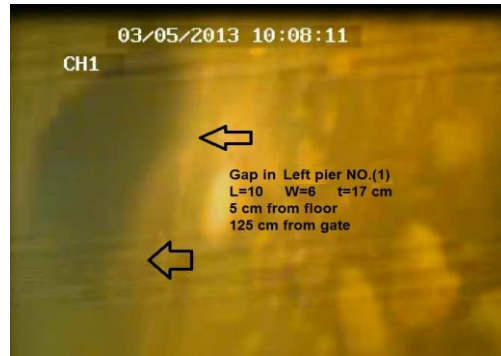
- Erosion exists along the emergency gates.
- Pier number (1) DS: Gap 10 cm length, 6 cm width, 17 cm thickness, 3.15 m under Water Level (WL), and 1.25 m from gate.

- Pier number (2) DS: Gap 43 cm length, 35 cm width, 30 cm thickness, 3 m under WL, and 2 m from gate.
- Pier number (1) US: Gap 16 cm length, 18 cm width, 20 cm thickness, 3 m under WL, and 0 m from gate.

- Pier number (2) US: Gap 43 cm length, 35 cm width, 30 cm thickness, 3 m under WL, and 2 m from gate.
- The floor is clear in the US
- Erosion existed in the floor DS with length 14 to 138 cm, width 6 to 132 cm, and thickness 12 to 200 cm.

Photos (7) and (8): Gaps in the piers

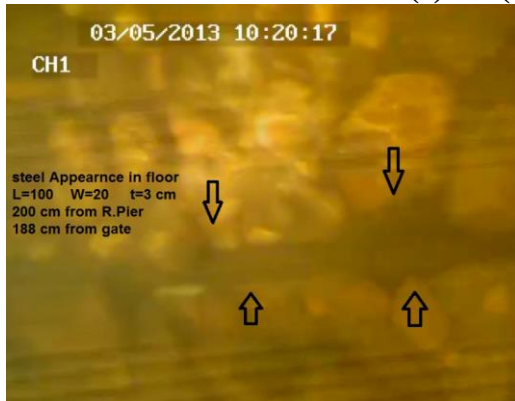
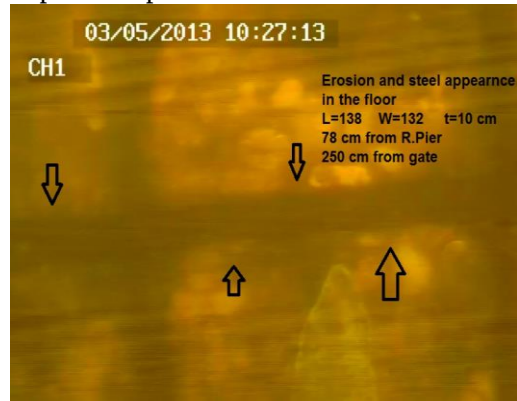
Photos (9) and (10): Floor Steel Erosion
